NACA RM L50G10

RESEARCH MEMORANDUM

FLIGHT MEASUREMENTS WITH THE
DOUGLAS D-558-II (BuAero No. 37974) RESEARCH AIRPLANE

LOW-SPEED STALLING AND LIFT CHARACTERISTICS

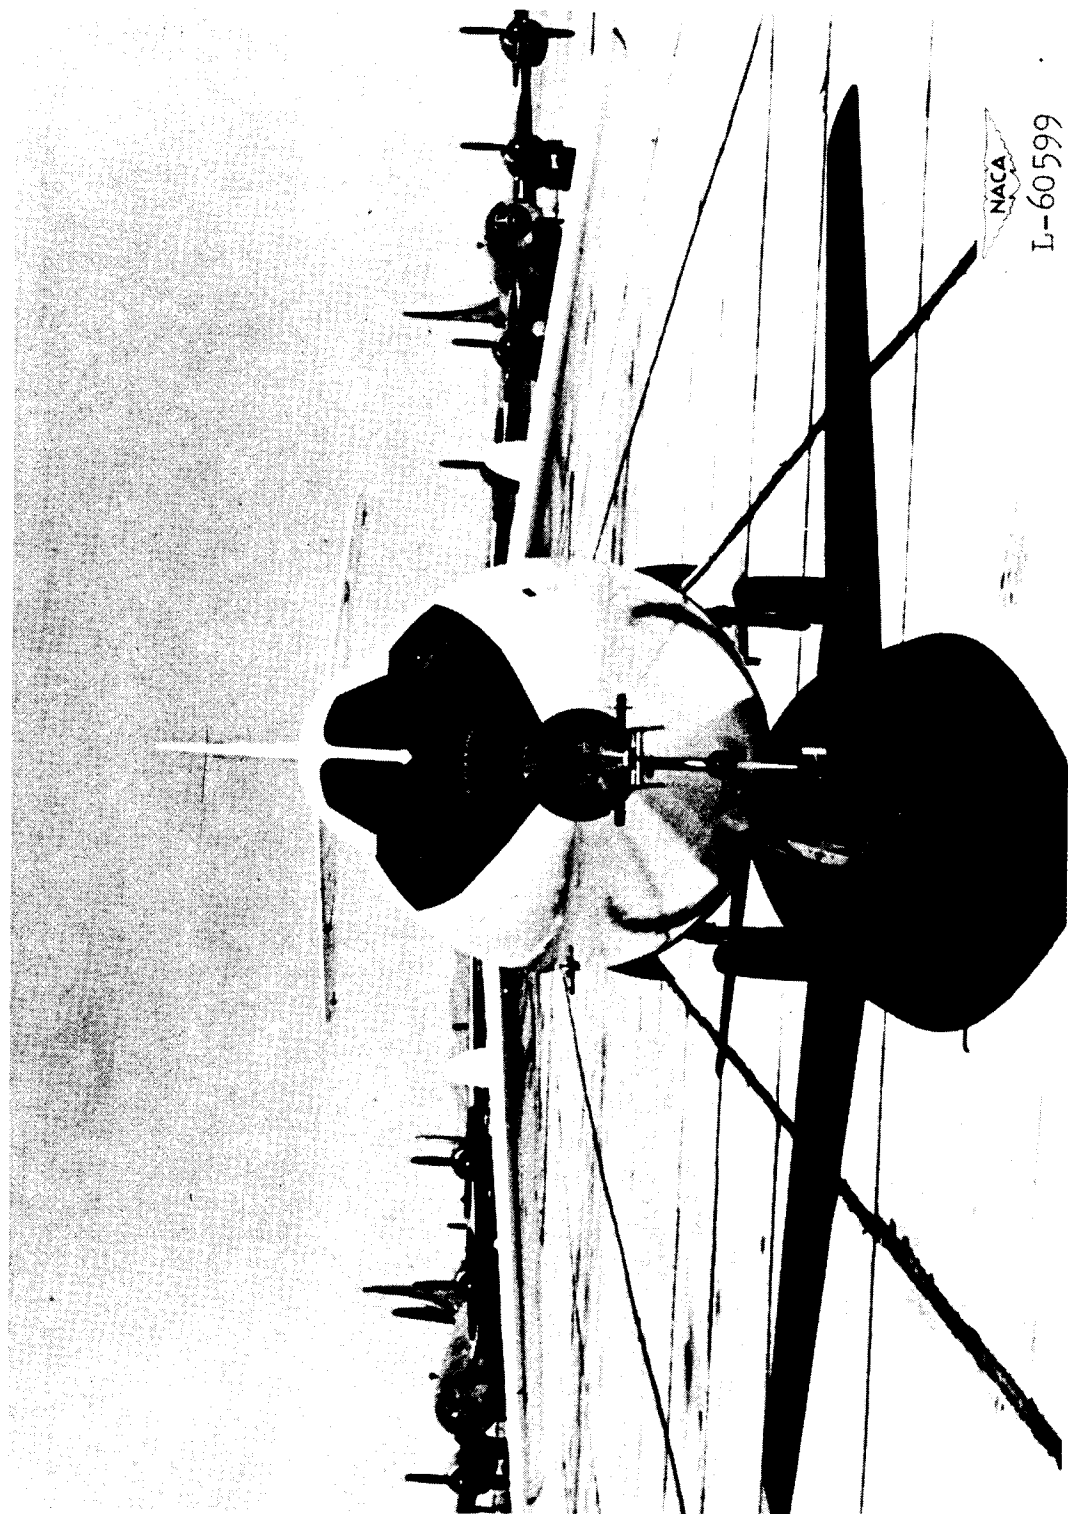
Figure 1.- Front view of Douglas D-558-II (BuAero No. 37974) research airplane.

a J-34-WE-40 turbojet engine which exhausts out of the bottom of the fuselage between the wing and the tail. Photographs of the airplane are shown in figures 1 and 2 and a three-view drawing is shown in figure 3. Pertinent airplane dimensions and characteristics are listed in table I.

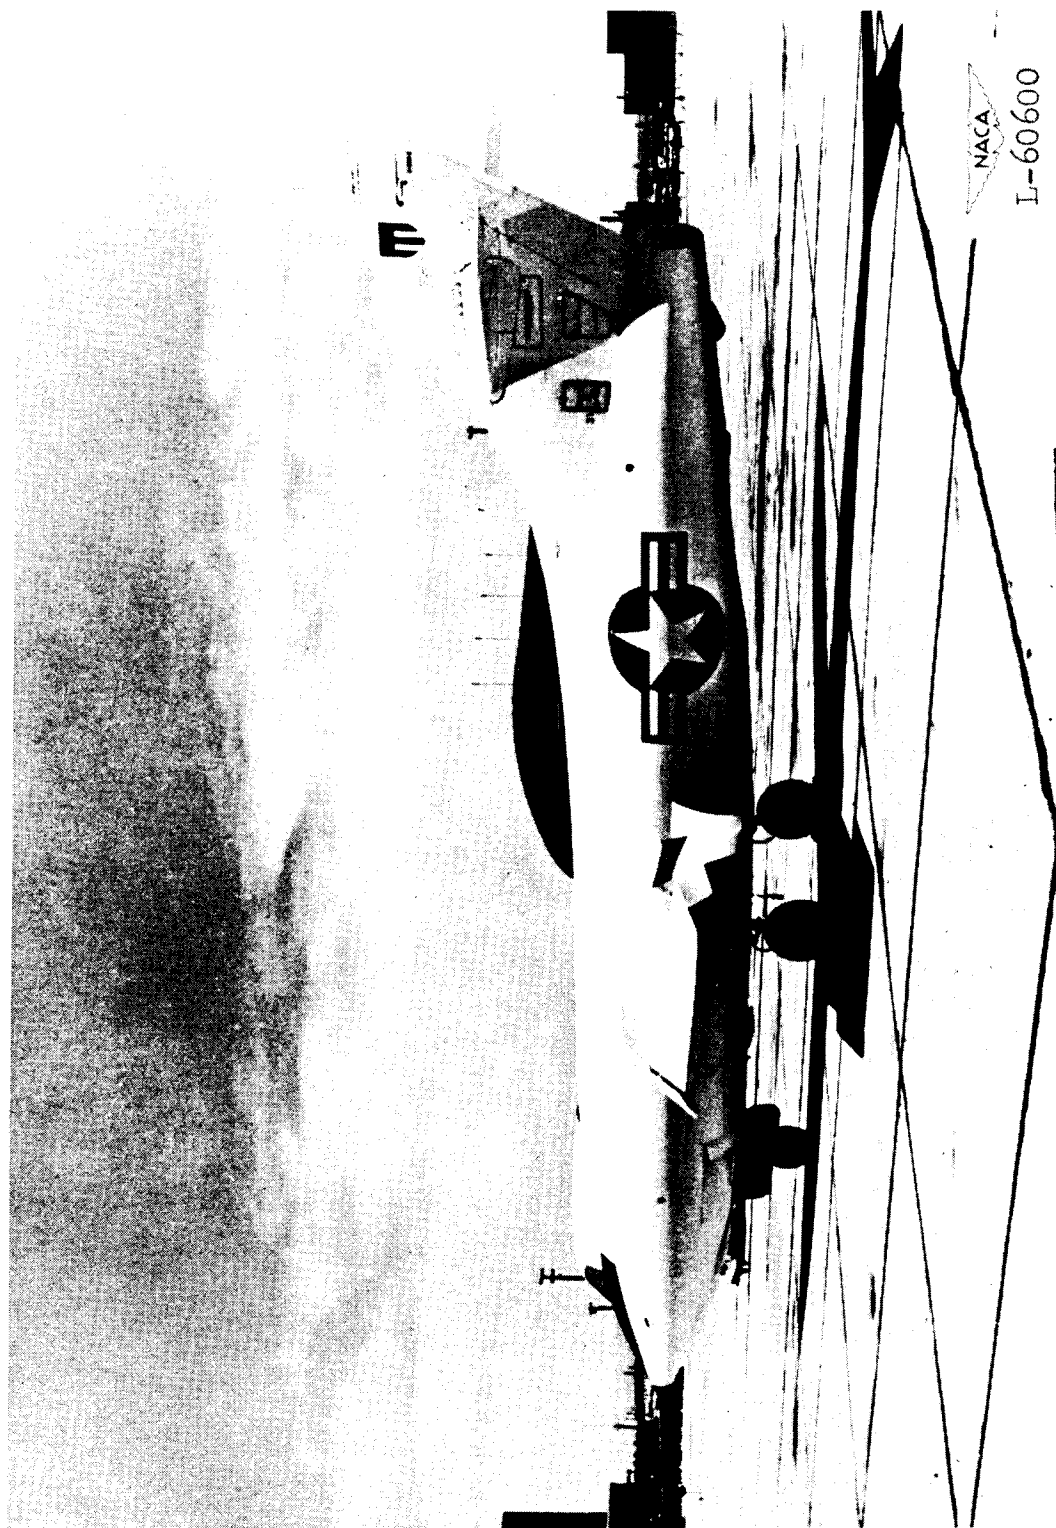
Figure 2.- Three-quarter rear view of Douglas D-558-II (BuAero No. 37974) research airplane.

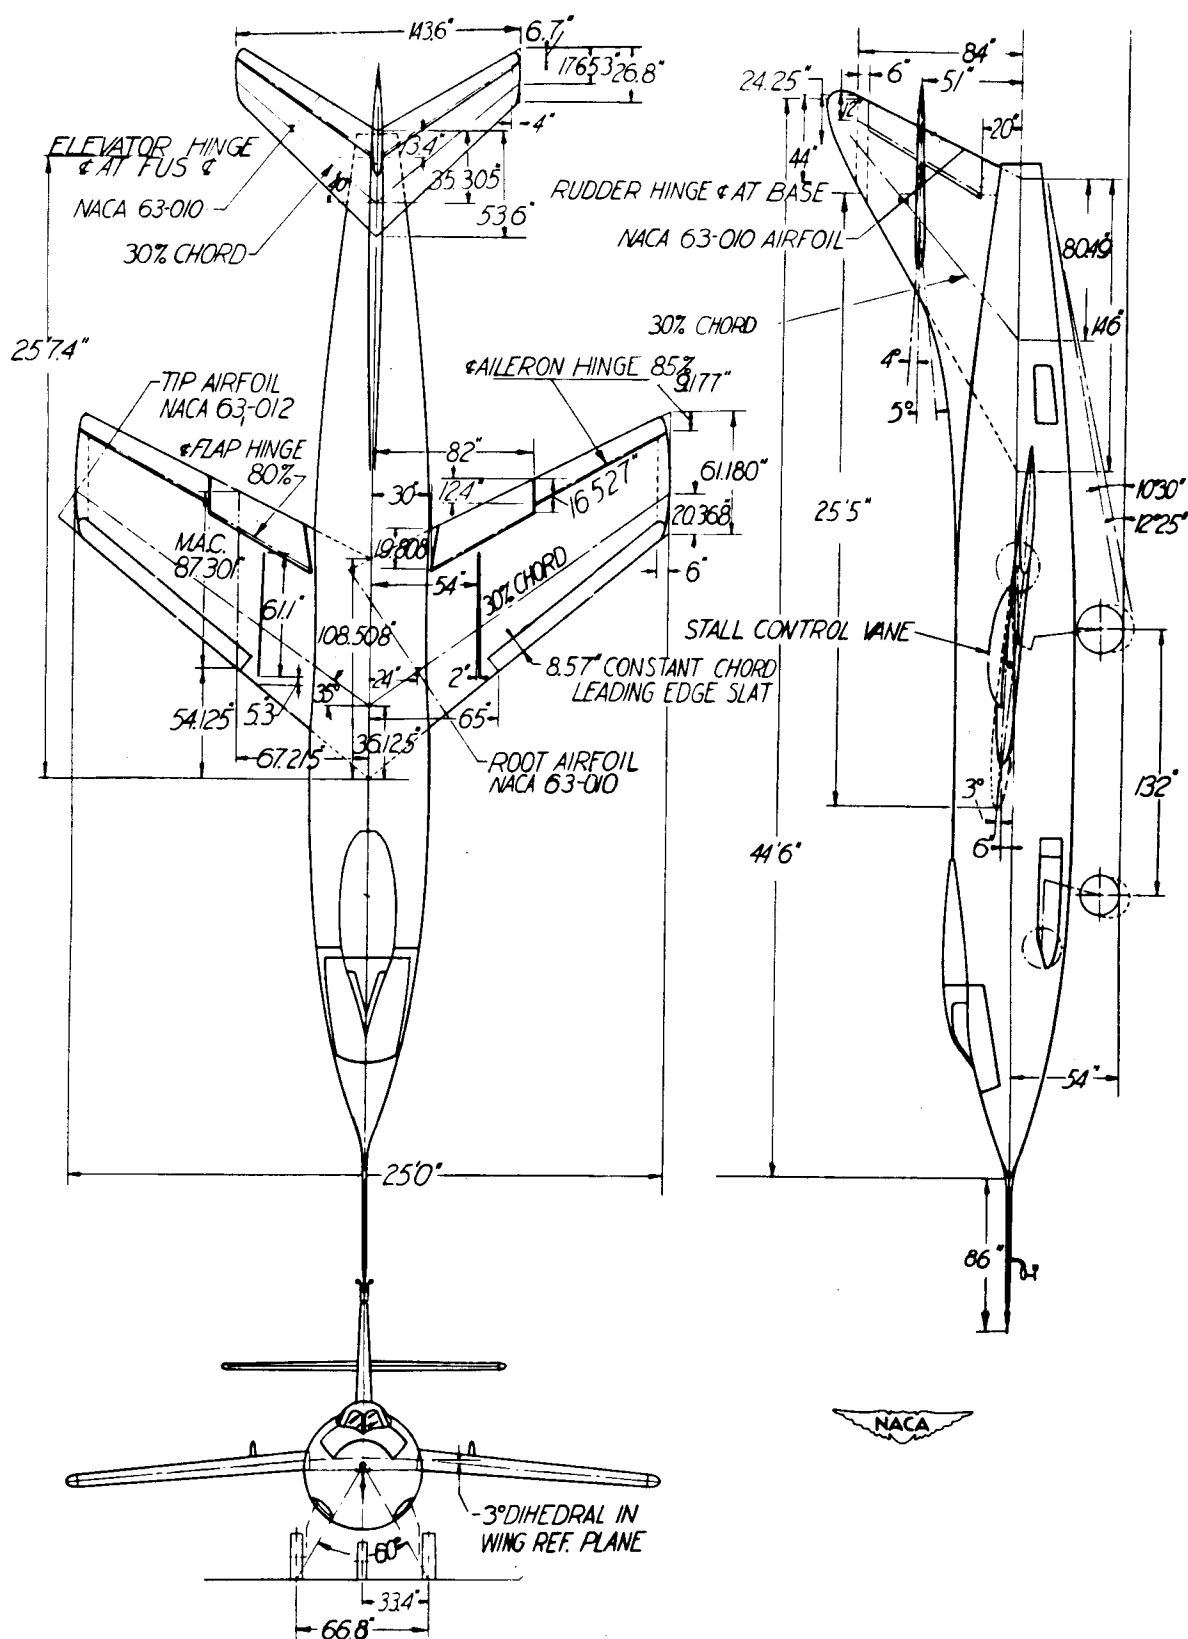
Figure 3.- Three-view drawing of the Douglas D-558-II (BuAero No. 37974) research airplane.

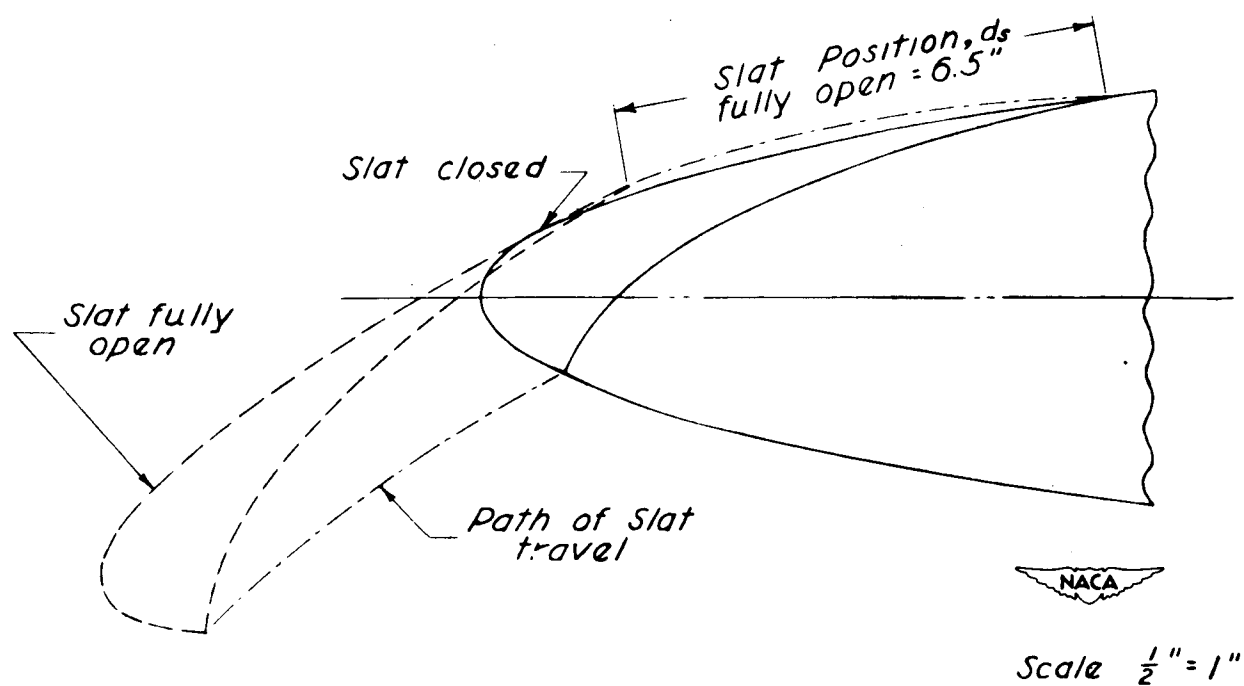
Figure 4.- Section of wing slat of Douglas D-558-II (BuAero No. 37974) research airplane perpendicular to leading edge of wing.

Both slats and fences are incorporated on the wing of the airplane. The wing slats can be locked in the closed position or they can be unlocked. When the slats are unlocked, the slat position is a function of the angle of attack of the airplane. Also, the slats on the left and right wings are interconnected and therefore, at any time, have the same position. A section view of the slat and the forward portion of the wing showing the motion of the slat with respect to the wing is shown in figure 4.

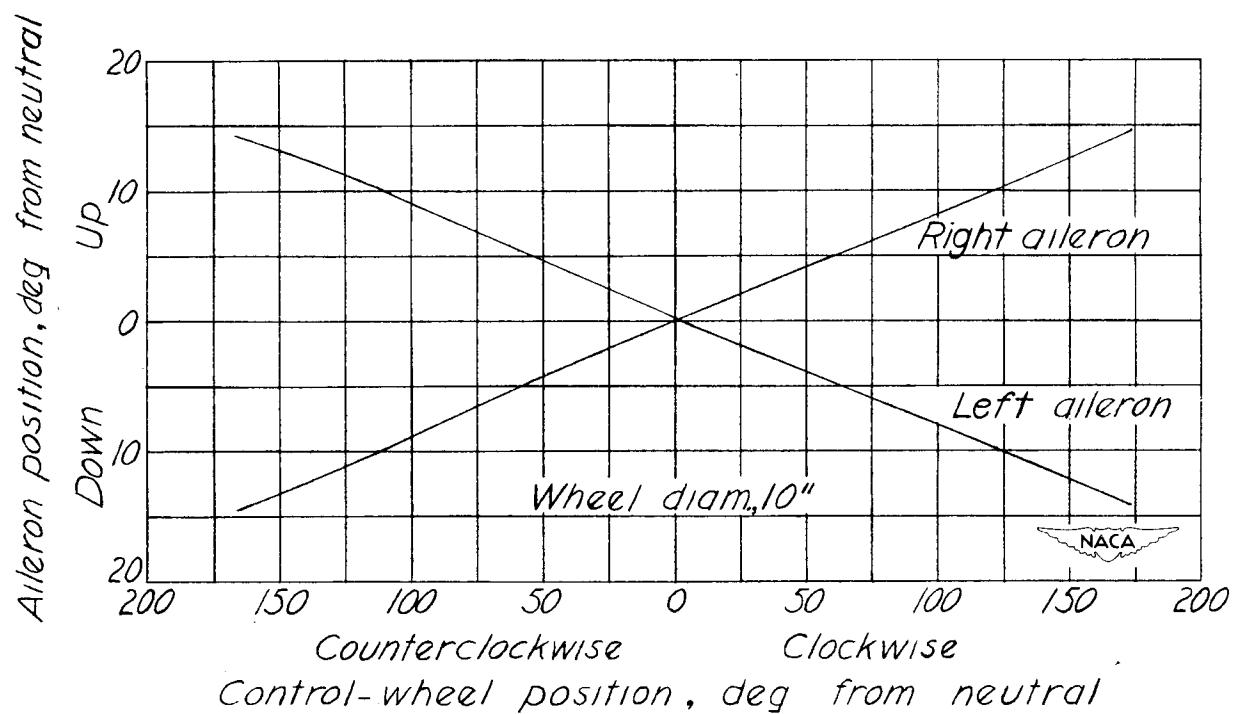
Figure 5.- Variation of left and right aileron positions with control-wheel position. No load on system.

The variations of aileron and elevator position with control-wheel position are shown in figures 5 and 6 and the variation of rudder position with right rudder pedal position is shown in figure 7. The friction in the control systems as measured on the ground under no load is shown in figures 8, 9, and 10. The friction measurements were obtained by measuring the control position and the control force as the controls were deflected slowly. The rate of control deflection was sufficiently low so that the control force resulting from the hydraulic dampers in the control system was negligible.

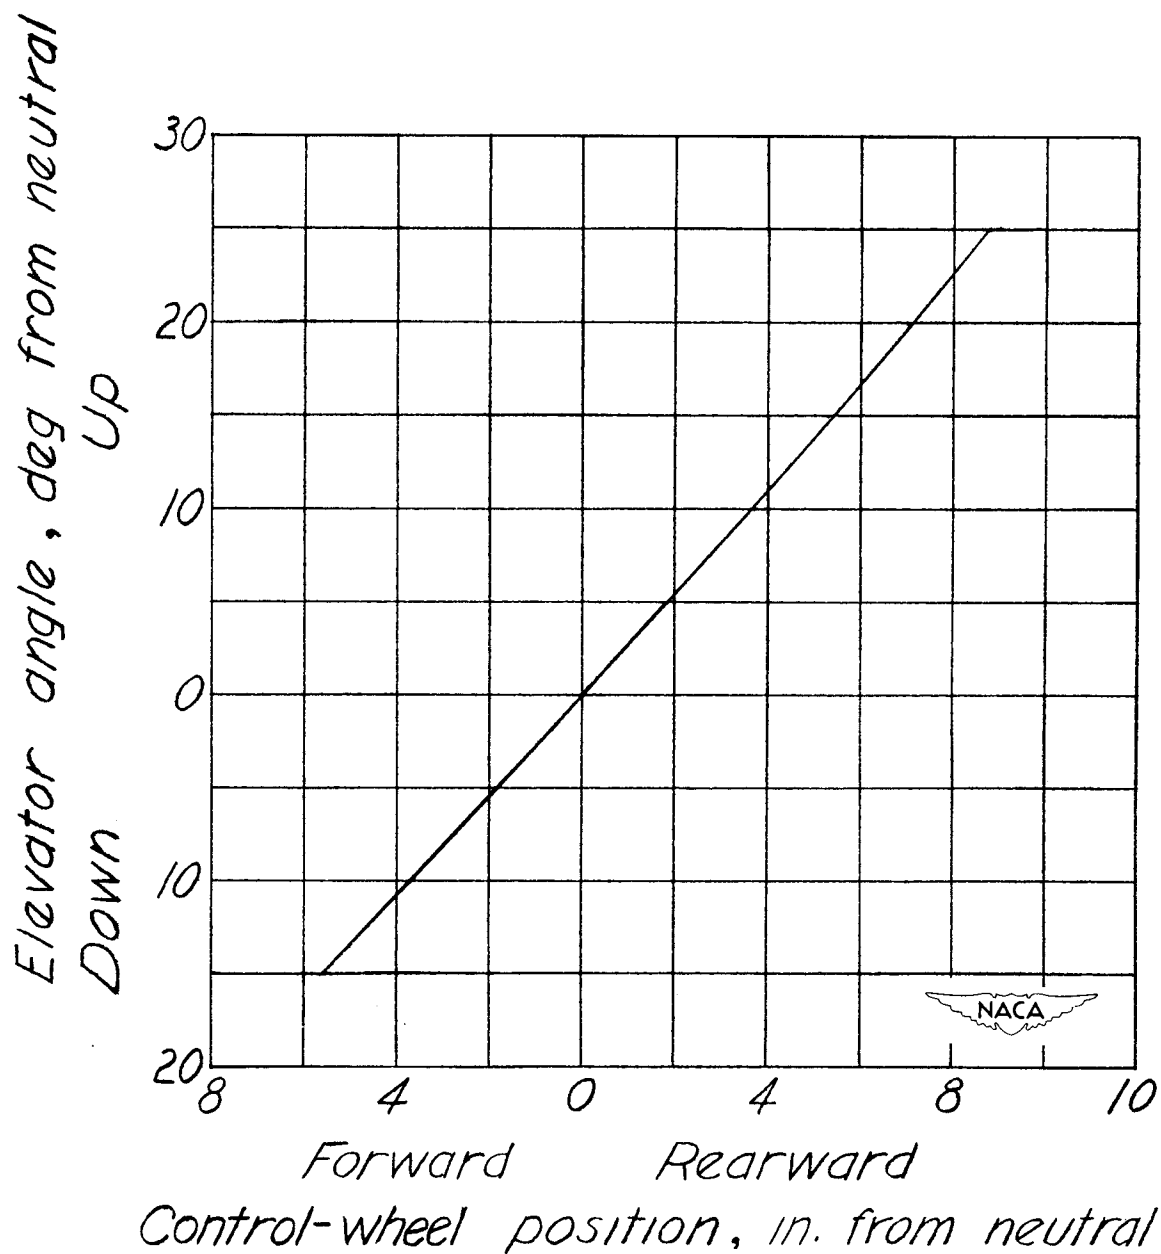
Figure 6.- Variation of elevator position with control-wheel position.
No load on system.

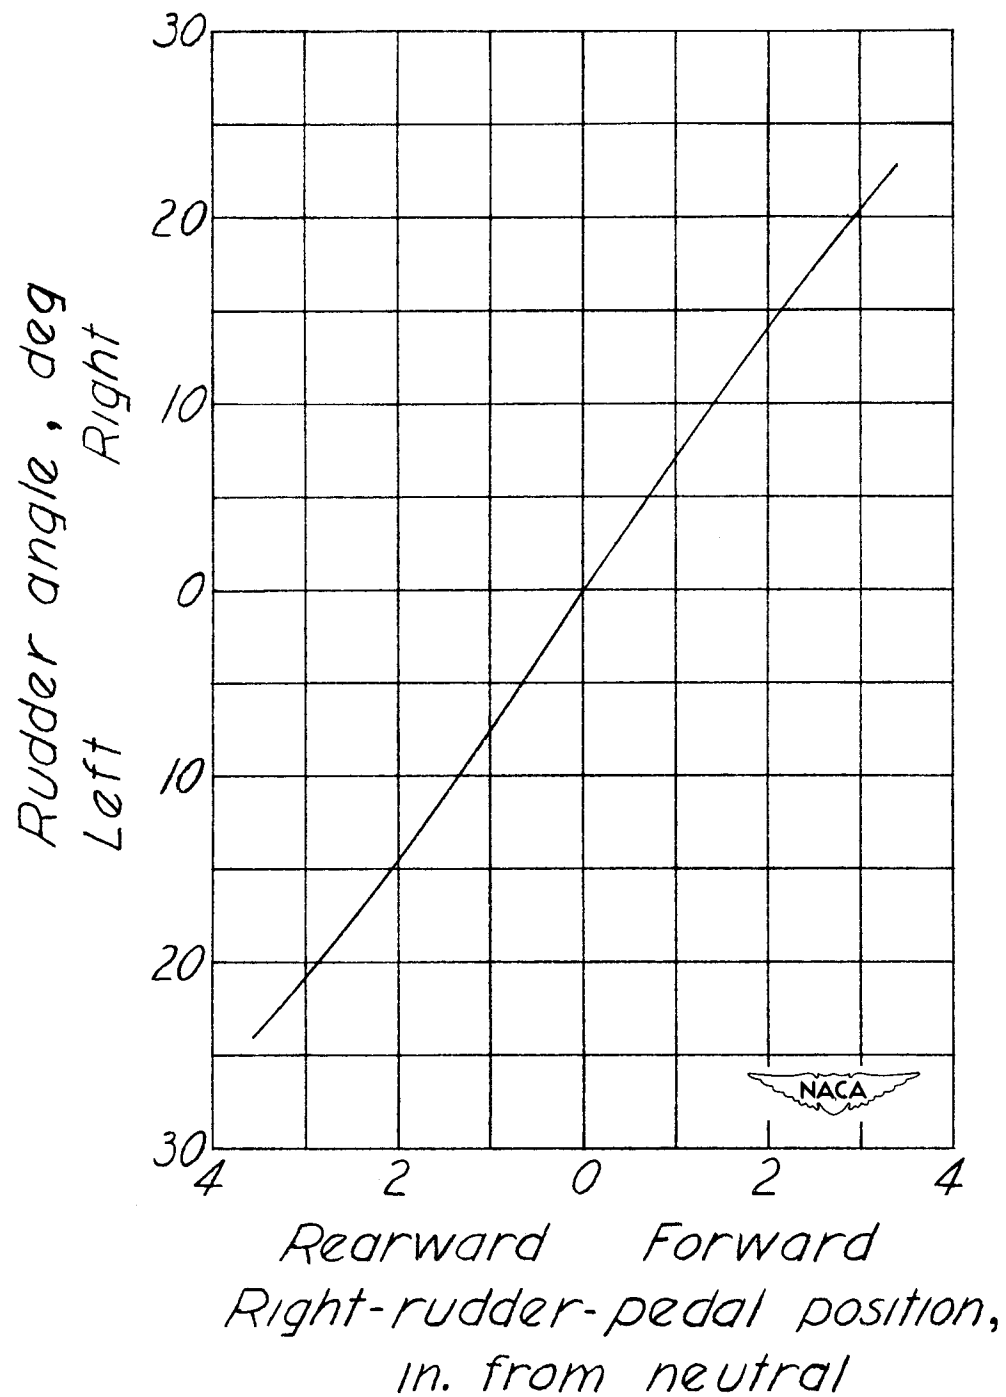
Figure 7.- Variation of rudder position with right-rudder-pedal position.
No load on system.

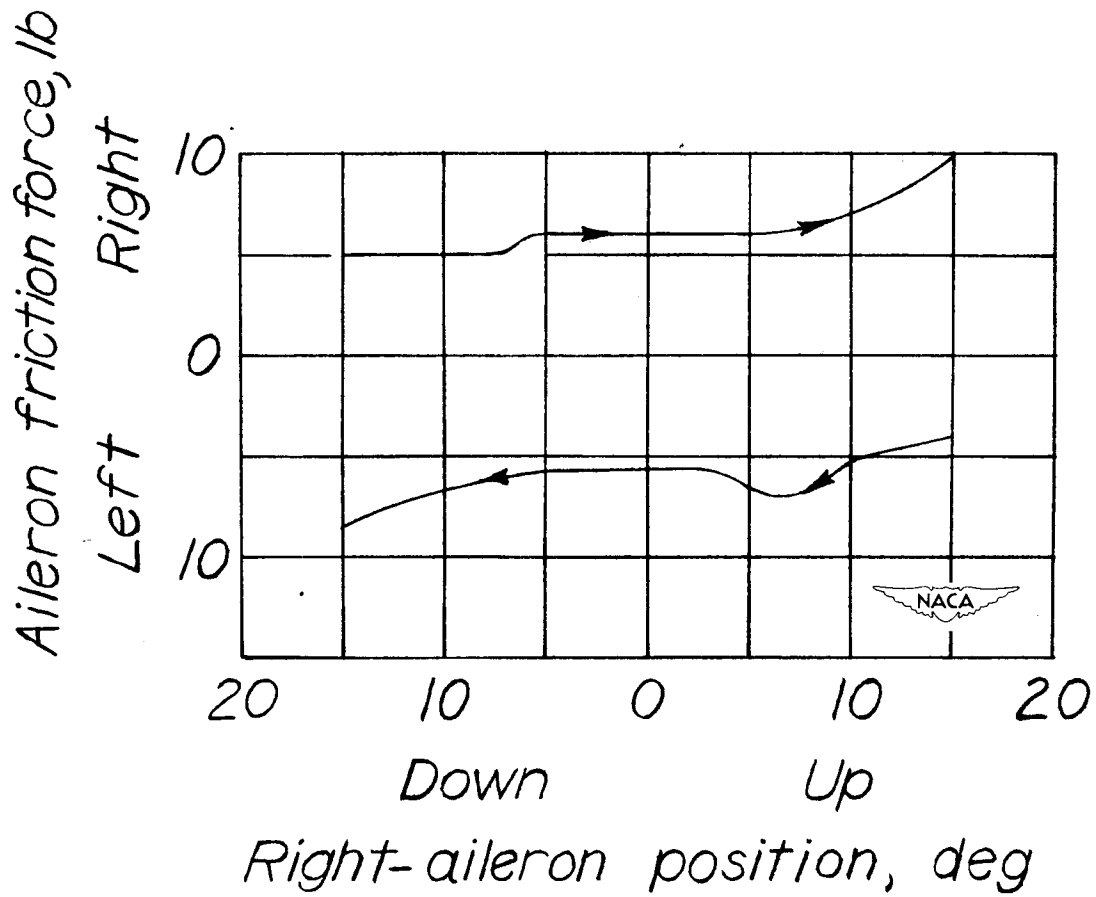
Figure 8.- Aileron-control force required to deflect ailerons on the ground under no load.

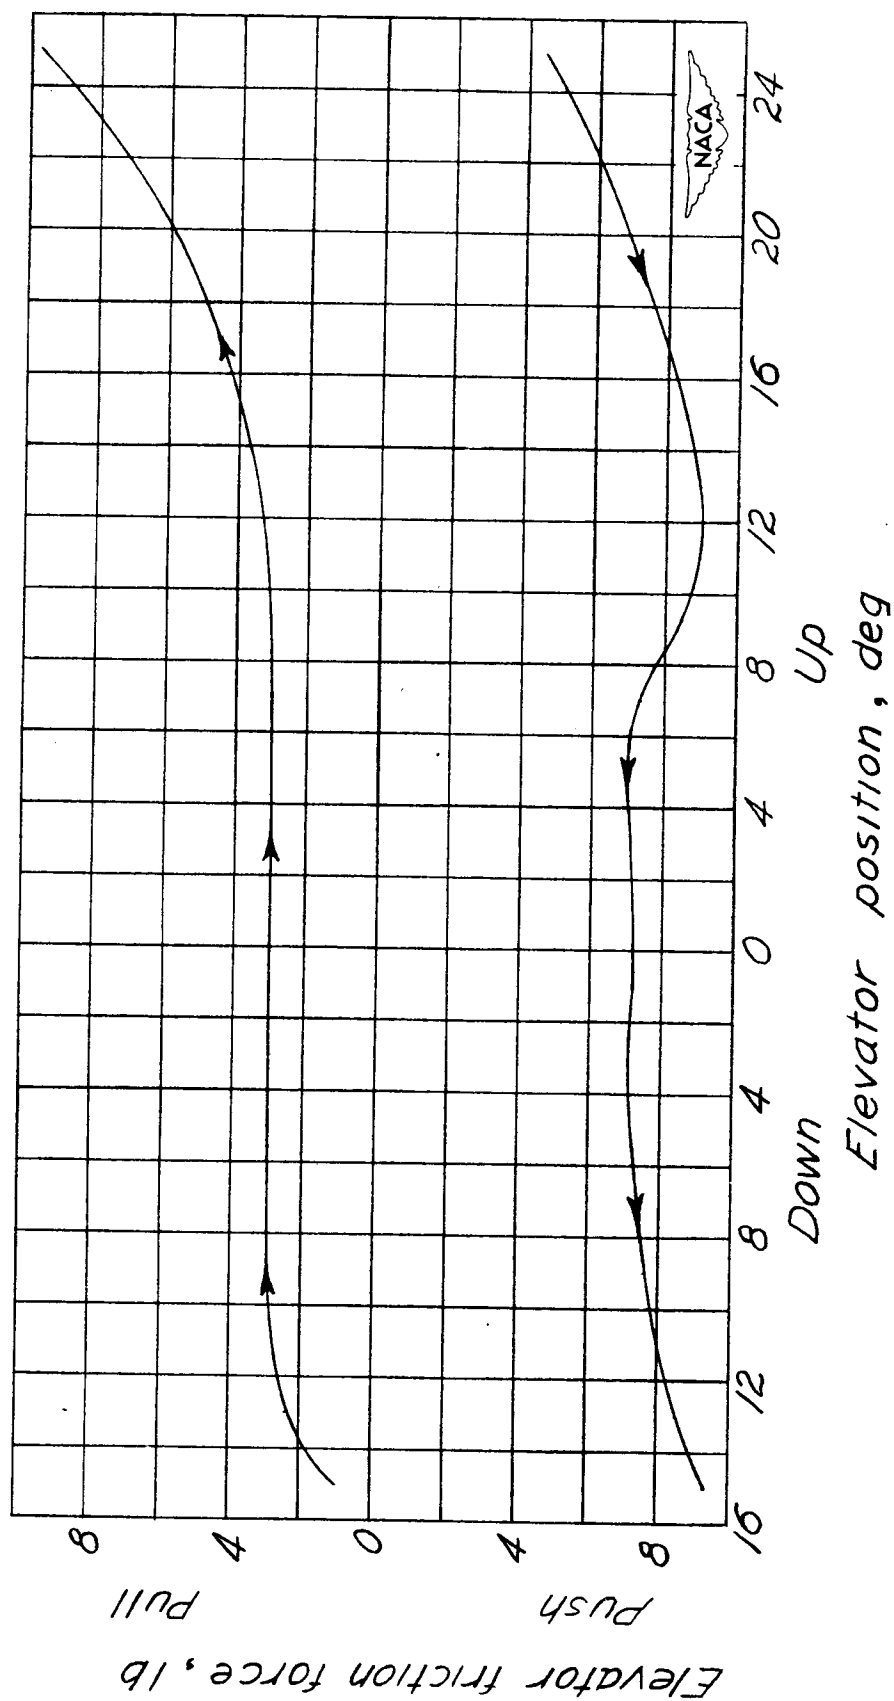
Figure 9.- Elevator-control force required to deflect elevator on the ground under no load.

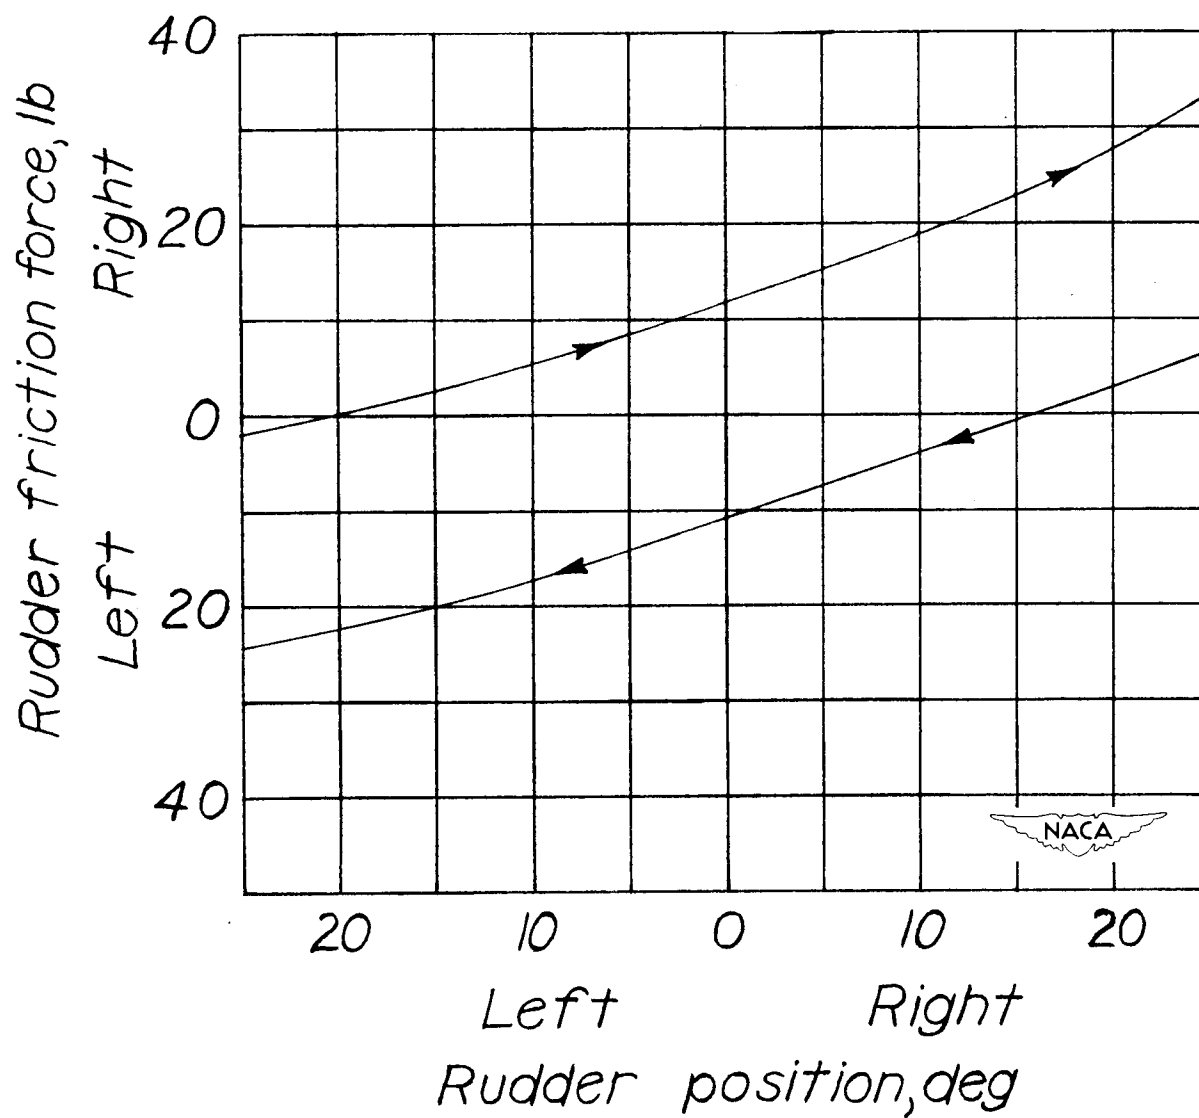
Figure 10.- Rudder-control force required to deflect rudder on the ground under no load.

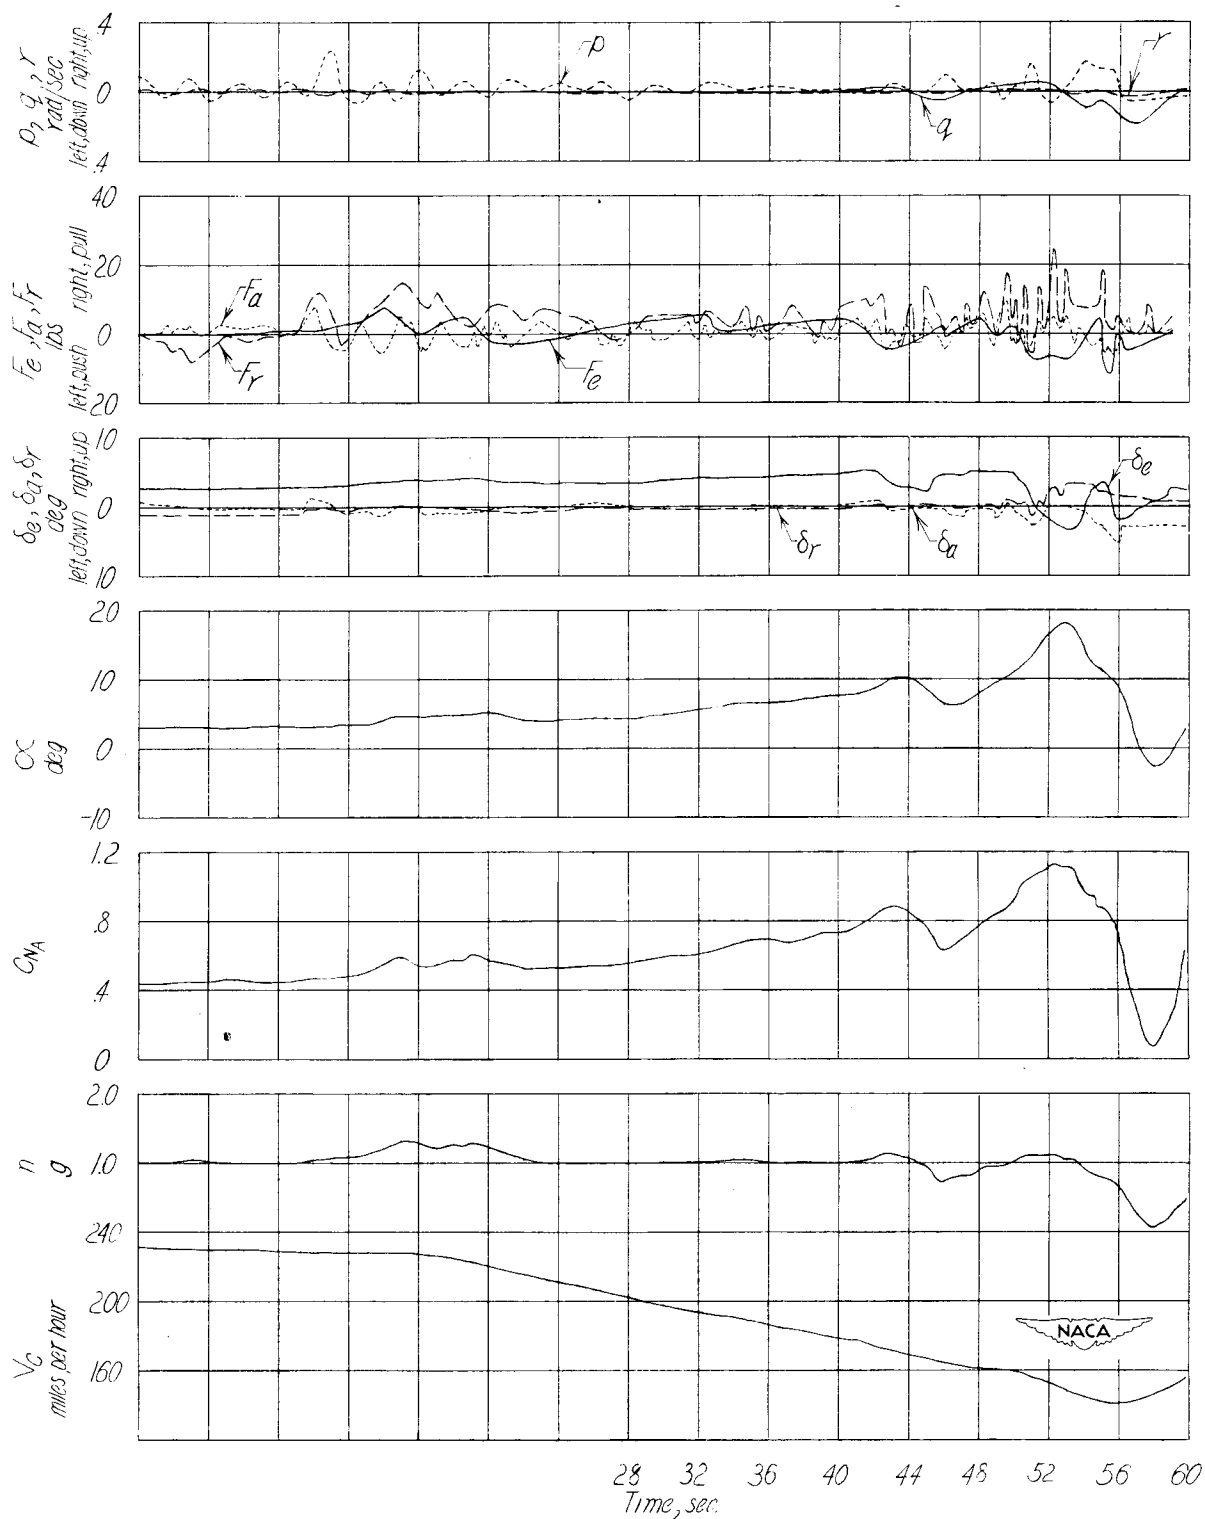
(a) Time history.

Figure 11.- Stall data for the Douglas D-558-II (BuAero No. 37974) research airplane. Flaps up; landing gear up; slats locked; inlet-duct flaps closed; stabilizer setting 1.95° ; center of gravity at 26.5 percent mean aerodynamic chord.

Flaps up, landing gear up, inlet-duct flaps closed, slats locked.-
A time history of a stall in this configuration is presented in figure 11(a). Presented in figure 11(b) are photographs of tufts on the wing at various times during the stall. The black lines on the wing are parallel to the airplane center line and are located at intervals of 25 percent of the semispan of the exposed wings. The times listed in figure 11(b) correspond to the times of figure 11(a). The run was started at an indicated airspeed of about 230 miles per hour and the minimum speed reached was about 142 miles per hour. A lateral oscillation, which was predominantly a rolling motion, persisted throughout the run. The data indicate that the airplane became longitudinally unstable

at a normal-force coefficient of 0.8 and an angle of attack of about 9° which, for 1 g flight, corresponds to an airspeed of about 165 miles per hour. When the airplane became unstable the pilot was required to use large down-elevator deflections to control the pitching. In figure 11(a) at times between 50 and 53 seconds, the elevator was moved from 5° up to 3° down but the angle of attack increased from 11° to 18.2° . The highest normal-force coefficient reached was 1.13 at an angle of attack of about 17.5° .

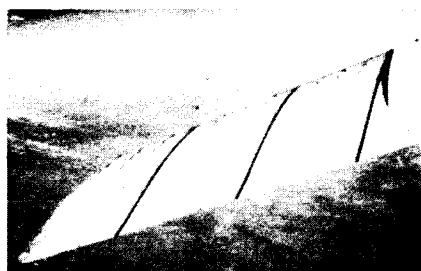
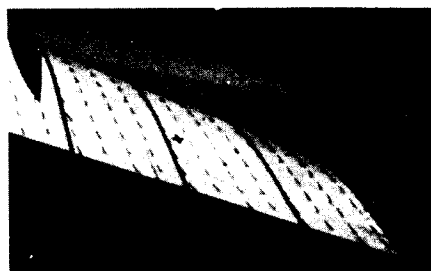
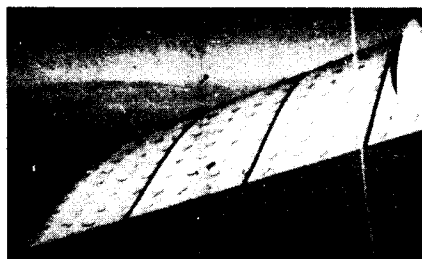
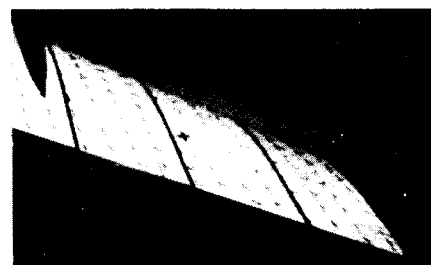
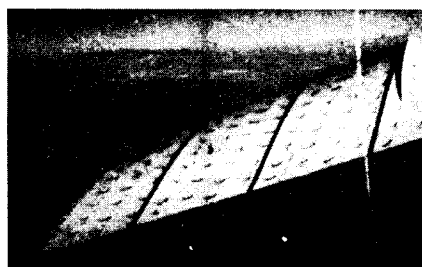
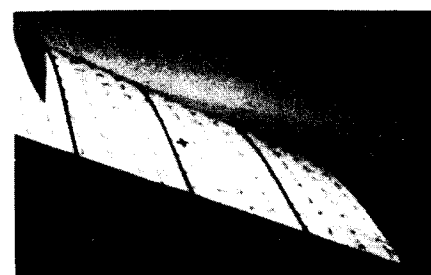
(b) Tuft pictures.

Figure 11.- Concluded.

Inspection of the tuft pictures of figure 11(b) shows that separation first occurs on the right wing between the 50- and 75-percent semi-span stations. At the same time there is a marked outflow on both wings outboard of the wing fences. As the angle of attack increases, the separation spreads over both the left and right wings and at the highest angle of attack reached, 18.2° , the entire wing appears to be stalled.

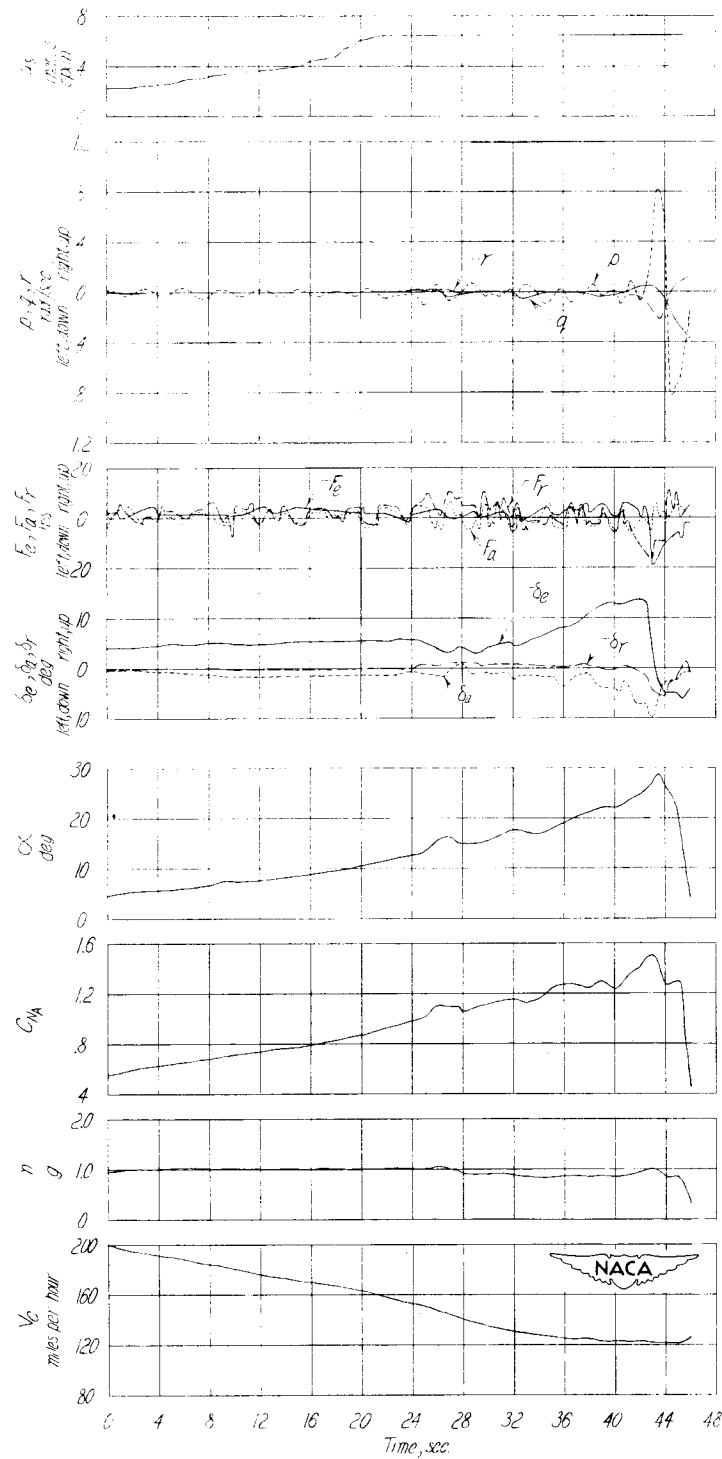
(a) Time history.

Figure 12.- Stall data for the Douglas D-558-II (BuAero No. 37974) research airplane. Flaps up; landing gear up; slats unlocked; inlet-duct flaps closed; stabilizer setting 1.95° ; center of gravity at 26.6 percent mean aerodynamic chord.

A time history of a stall in this airplane configuration is presented as figure 12(a) and tuft pictures at various times during the stall are shown in figure 12(b). The approach to the stall was started at about 200 miles per hour and the minimum speed reached was about 122 miles per hour. At times between 24 and 29 seconds (in the speed range from 155 to 140 miles per hour), the data indicate that the airplane was slightly unstable longitudinally since the up-elevator deflection required for trim decreased as the angle of attack and normal-force coefficient increased. The pilots did not have any serious objections to the slight instability present in this speed range. From 140 miles per hour down to a speed slightly above the minimum speed reached (122 miles per hour), the airplane was stable longitudinally. Near the minimum speed or at the higher angles of attack (23° to 28.5°) the data indicate that the airplane was again unstable. At 42.5 seconds the elevator was quickly moved down but between 42.5 and 43.5 seconds the angle of attack increased from 26° to 28.5° . A rolling and yawing motion was present when the airplane was unstable at the high angles of attack. These motions were objectionable to the pilots and were much more noticeable than the longitudinal instability. Recovery from the stall was accomplished by moving the elevator down.

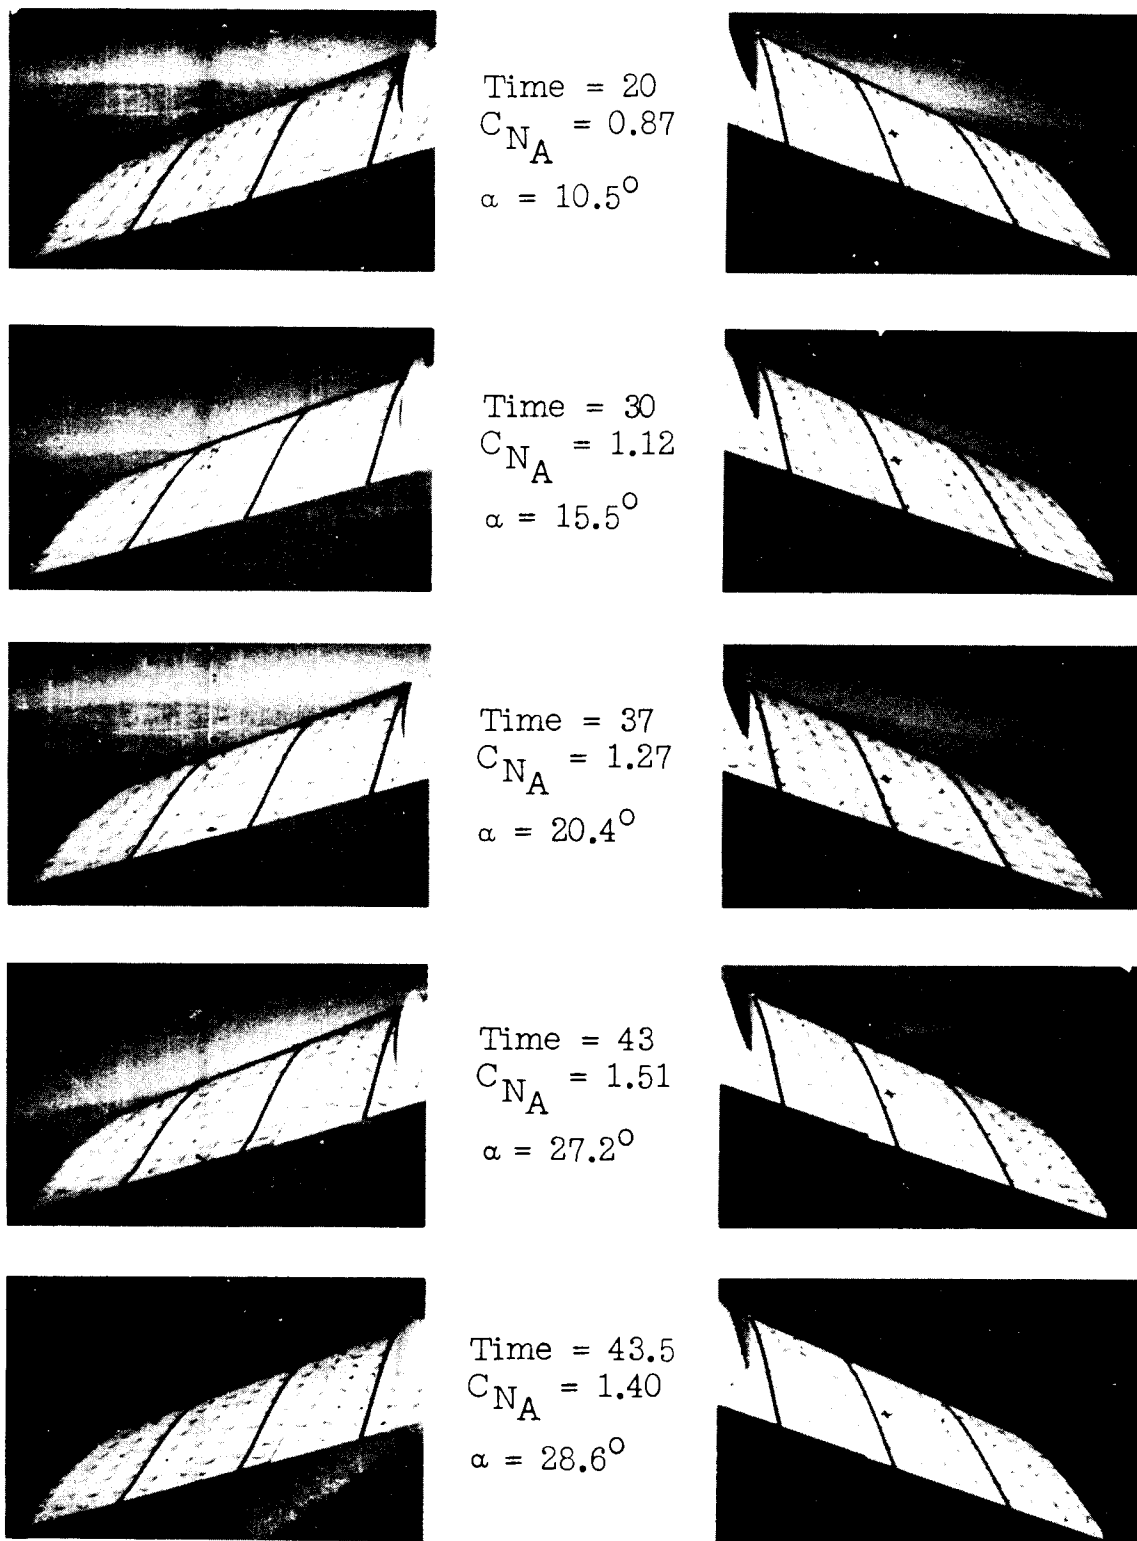
(b) Tuft pictures.

Figure 12.- Concluded.

The tuft pictures of figure 12(b) show the wing first stalls between the fuselage and the 50 percent wing semispan. At the same time

there is outflow over the outer part of the wing panel. As the angle of attack increases, the stall spreads outboard over both wings. The tuft pictures for the time 43 seconds in figure 11(b), (the slats-locked configuration), are for about the same angle of attack and air-plane normal-force coefficient as the tuft pictures of the time 20 seconds in figure 12(b). Comparison of these tuft pictures indicates that the slats are effective in delaying separation since at 43 seconds in figure 11(b) the tufts show an appreciable separation but at 20 seconds in figure 12(b) the flow appears to be smooth.

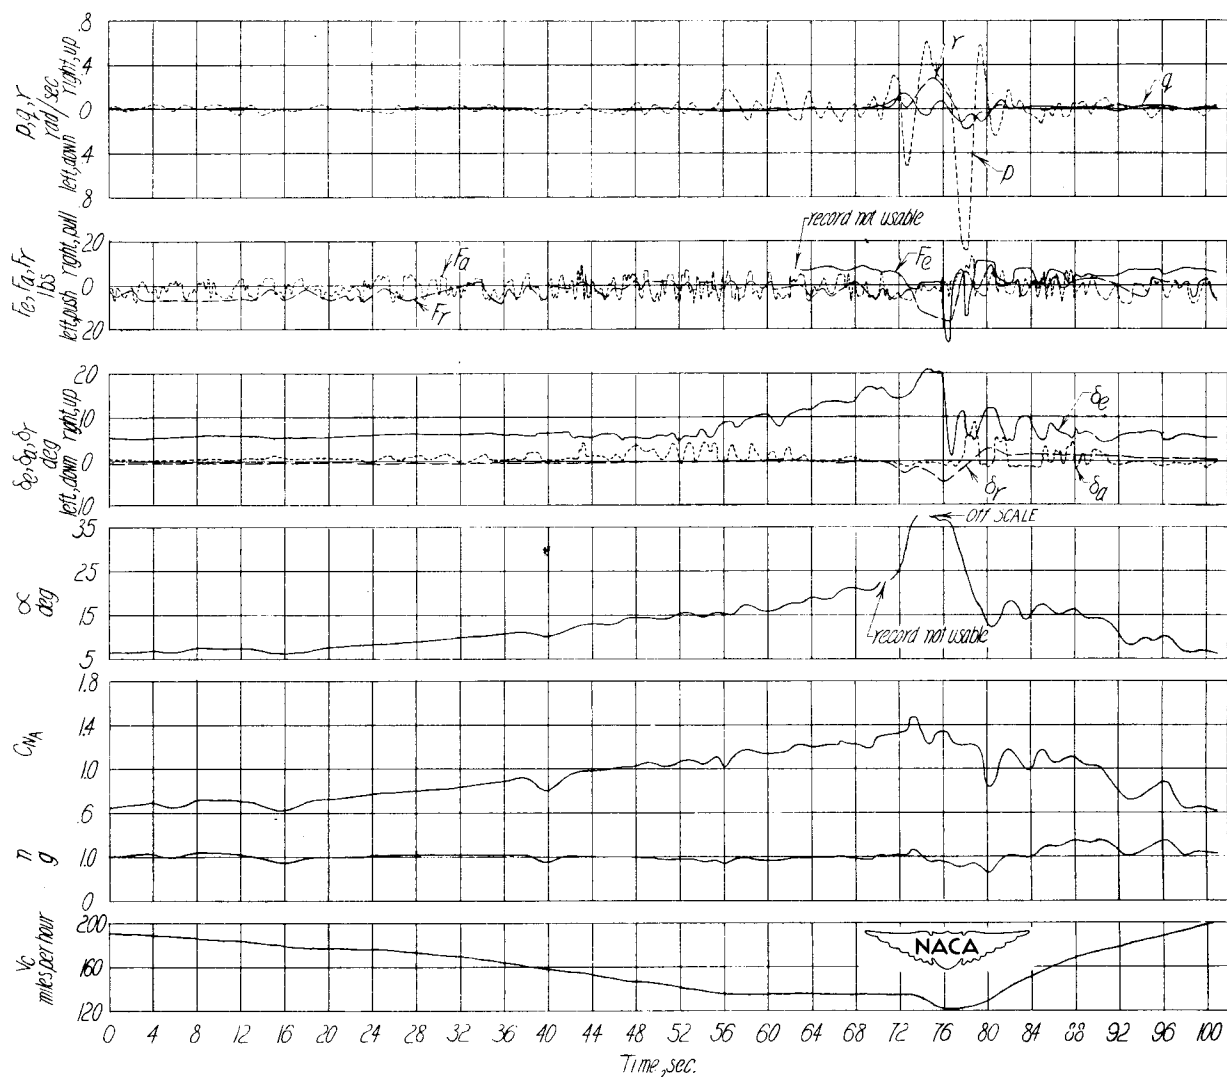
Figure 13.- Time history of a stall with the Douglas D-558-II (BuAero No. 37974) research airplane. Flaps up; landing gear up; slats unlocked; inlet duct-flaps closed; stabilizer setting 1.72° ; center of gravity at 26.7 percent mean aerodynamic chord.

The stall presented in figure 13 shows the same characteristics as that in figure 12(a), except that recovery was made after the airplane had reached a higher angle of attack. (The range of the angle-of-attack recorder was exceeded at 38° .) The approach to the stall was started at 190 miles per hour and recovery was made at 122 miles per hour. At the higher angles of attack the airplane was longitudinally unstable. At times between 70 and 72 seconds the elevator is moved down, but at the same time the angle of attack increases rapidly. Also at times between 72 and 75 seconds when the elevator is being moved up, the angle of attack is leading rather than lagging the elevator motion. The highest normal-force coefficient reached was 1.47 at an angle of attack of about 36° . Recovery from the stall was accomplished by moving the elevator down. The longitudinal instability which occurred in this airplane configuration at angles of attack greater than about 23° was not nearly so objectionable to the pilots as the instability which occurred in the slats-locked configuration previously discussed. With the slats locked the instability occurred at a much lower normal-force coefficient or angle of attack and the pitch-up was more rapid.
